# Landcruiser 200 Series Fitting Issue

**Body NOT central on chassis preventing carriers from opening properly**

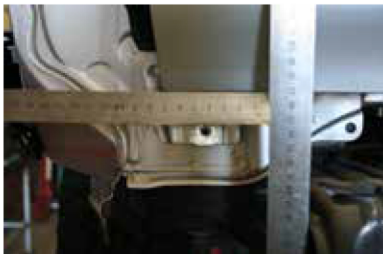
On this particular vehicle the body has been mounted 8mm off centre to the drivers side.

Passenger side  
measurement 72mm

For the carrier to work correctly and not touch the bumper, cut 4mm (in this example) off the top and bottom stop of the corner bracket - see photo below

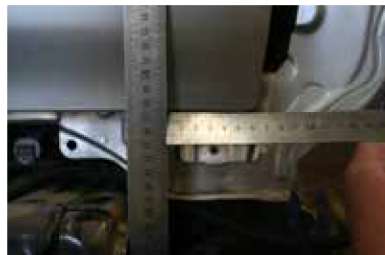
Driver side  
measurement 64mm
